1701/1702 BLOCK DIAGRAM

TROUBLESHOOTING GUIDE — 1702

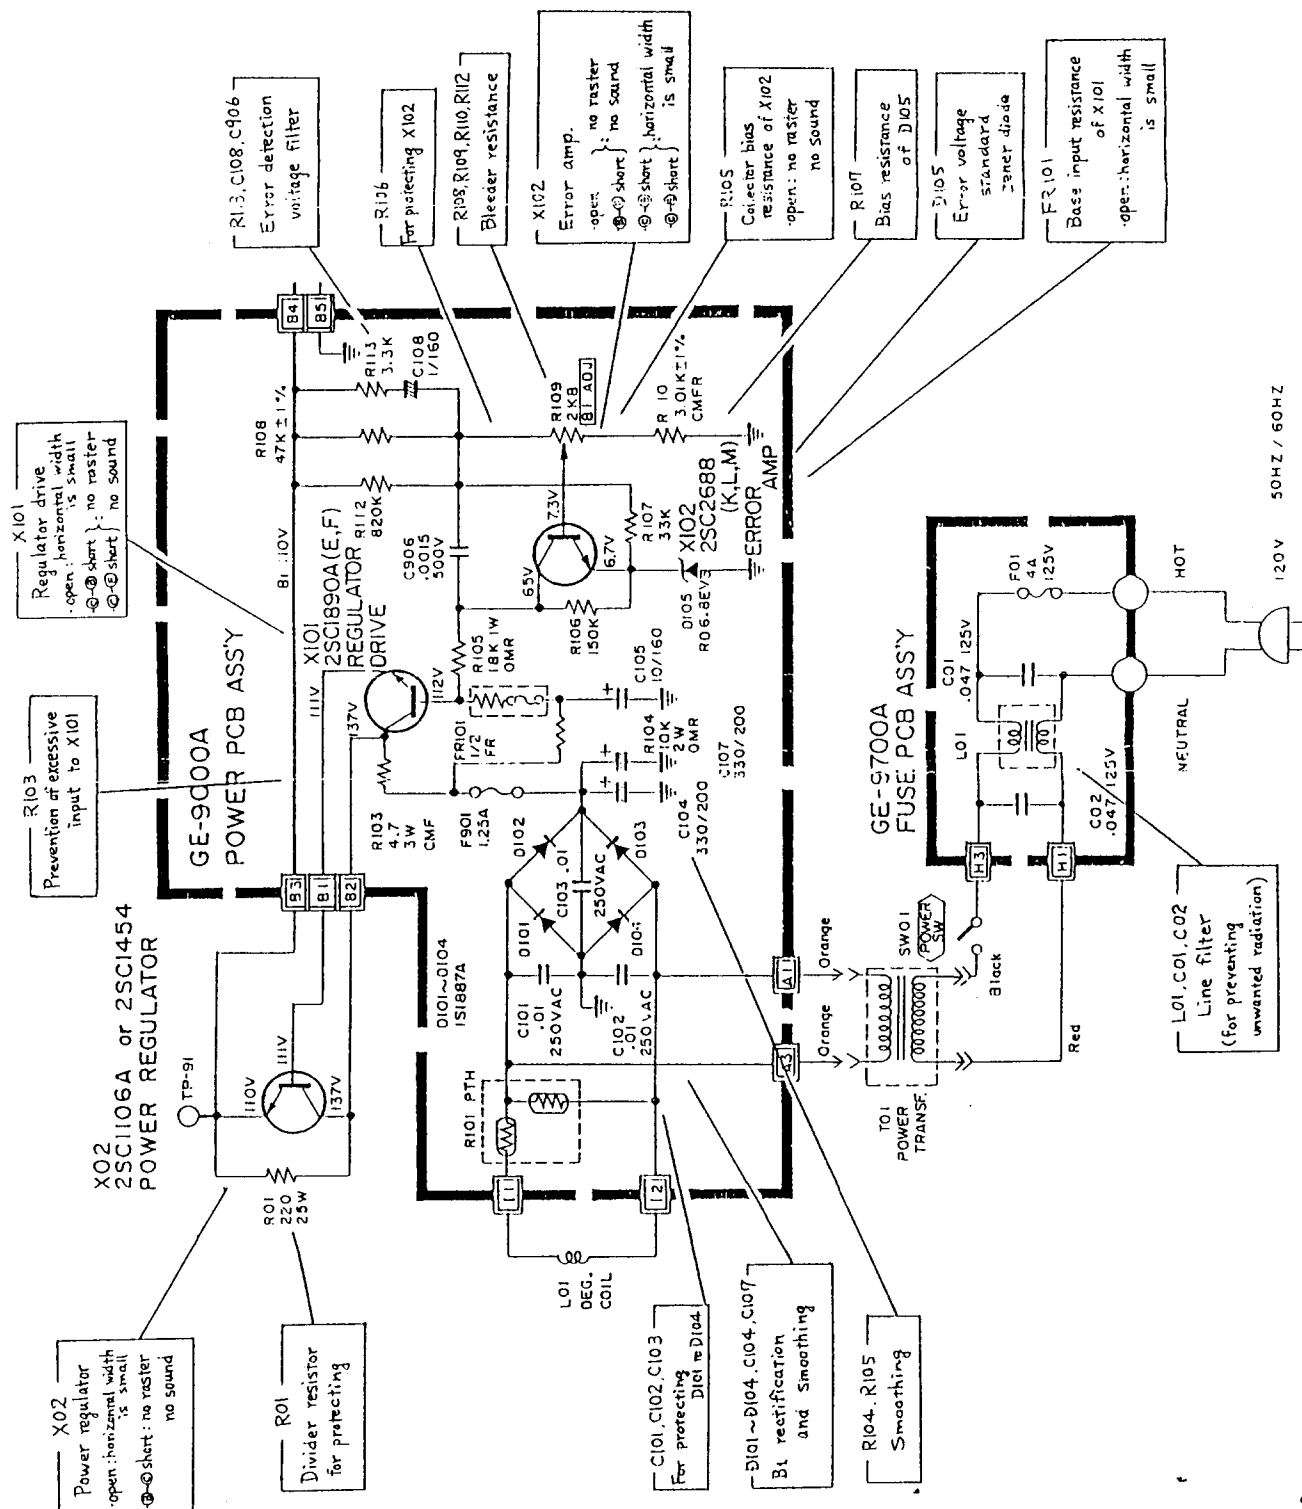
POWER CIRCUIT

CIRCUIT NOTES

Although specifically written on the 1701 monitor, most circuit theories apply to the 1702 also. Refer to the 1702 schematic for differences in component values and identification.

1. When D105, R105, R108, R109 are open, the base voltage of X101 and X102 rise to increase B₁ voltage to more than 130V. This causes the X-ray protector to work, resulting in no raster.
2. If the base voltage drops as when R103 is open or C105 is shorted, the B₁ voltage is reduced to less than 40 V. This will mostly result in no raster, no sound.
3. When the B₁ voltage drops to about 70 V, because R910 is open and D105 is shorted, the screen becomes dark and the raster size is reduced because of insufficient horizontal and vertical amplitude.

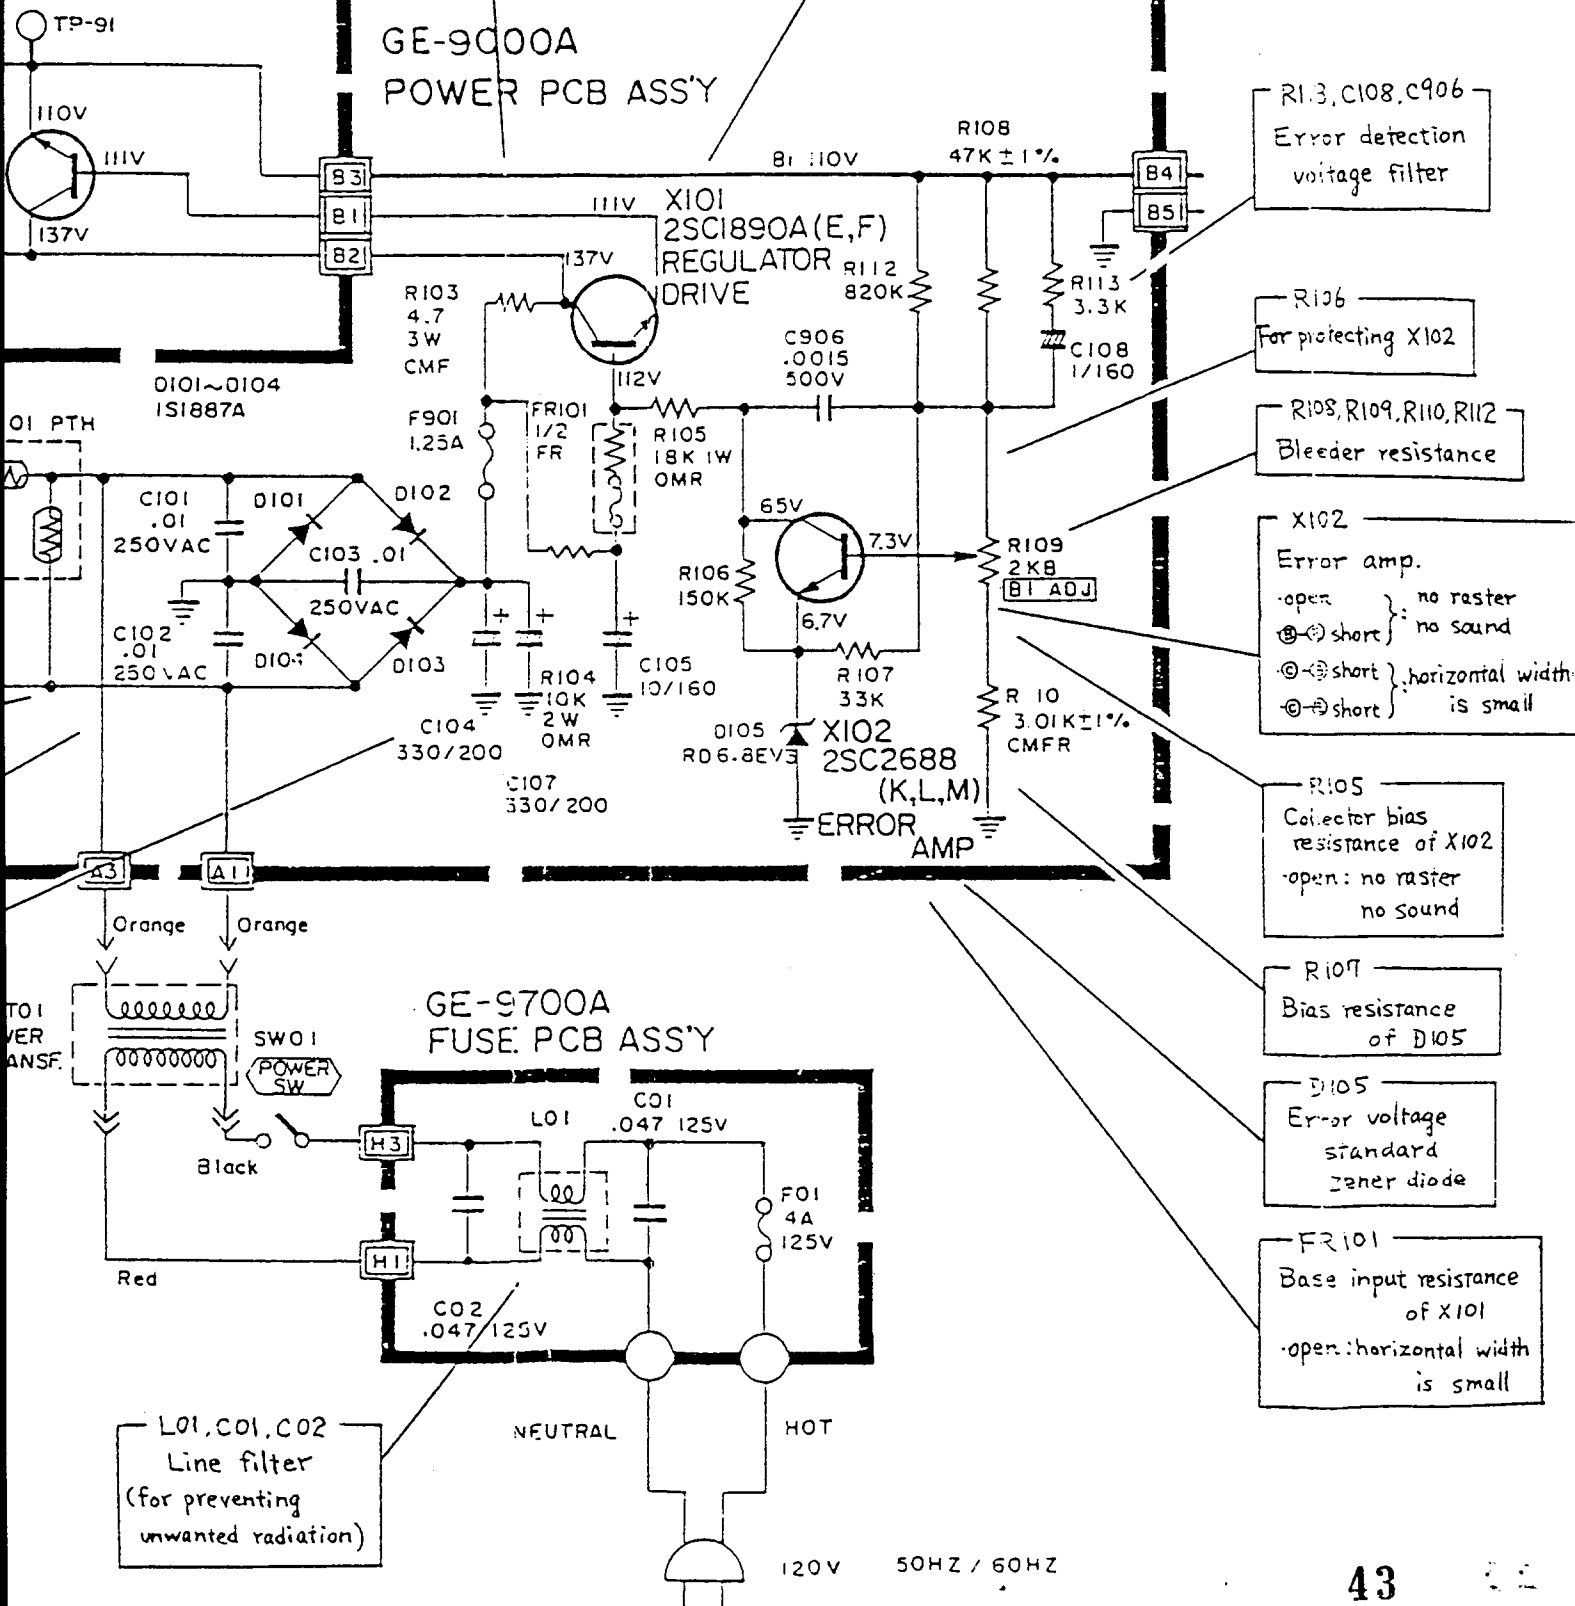
R103
Prevention of excessive
input to X101

X101
Regulator drive
open: horizontal width
is small
⊖-⊖ short } no raster
⊖-⊕ short } no sound

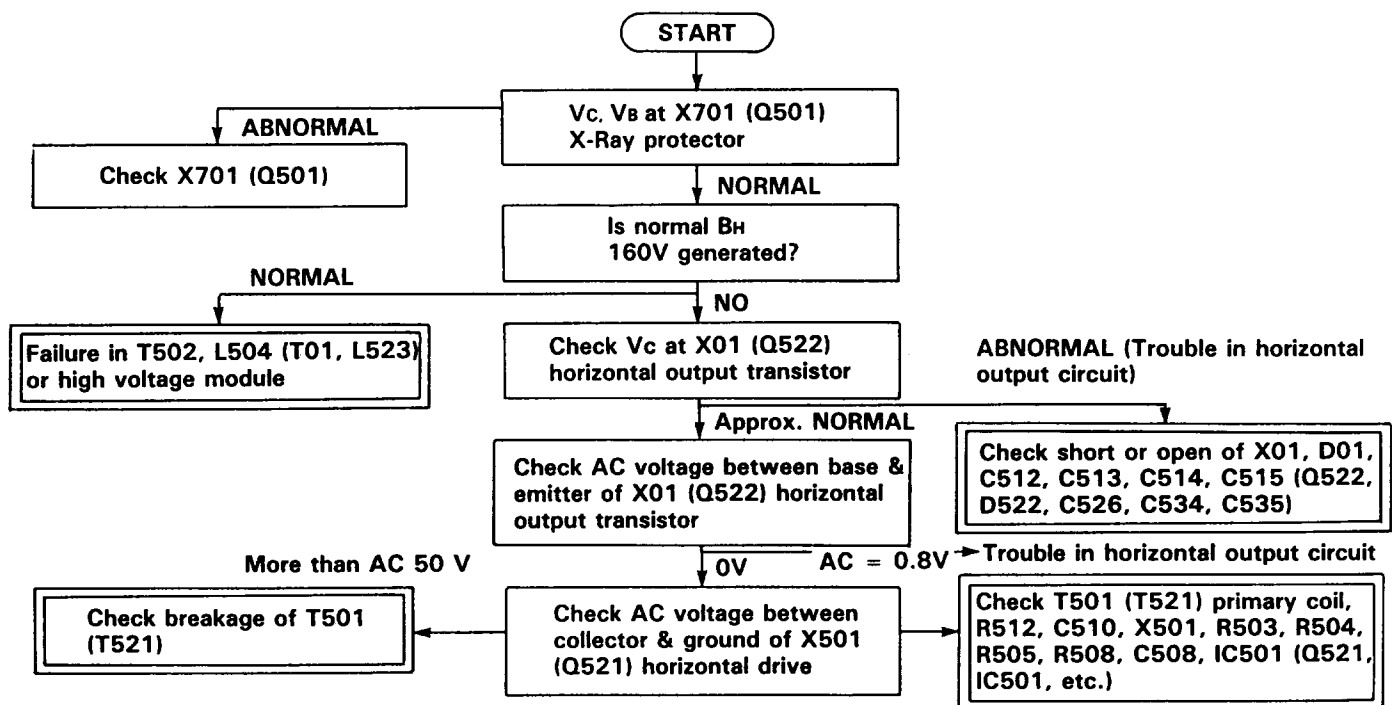
1. As long as normal B_H 160V is generated, the horizontal output circuit properly operates, producing pulses during the flyback period of the saw-tooth wave current passing through the horizontal deflection coil. If a problem is found with normal B_H voltage, the problem area should be the secondary coil of the flyback transformer.

2. When the AC voltage between base and emitter of the horizontal output transistor X01 (Q522) is about 0.8V, it is supplied with input pulses. The problem is therefore in the horizontal output circuit. When, however, X01 (Q522) is shorted, this AC voltage is not indicated even if there are input pulses at X01 (Q522).

3. AC voltage is measured between the collector and ground of X501 (Q521) horizontal drive as shown. When the specified voltage is shown on the meter, the horizontal output circuit is the problem; while, when there is no voltage indication, the trouble is in some element(s) preceding X501 (Q521). Check if those transistors and ICs are damaged using a voltage measurement.

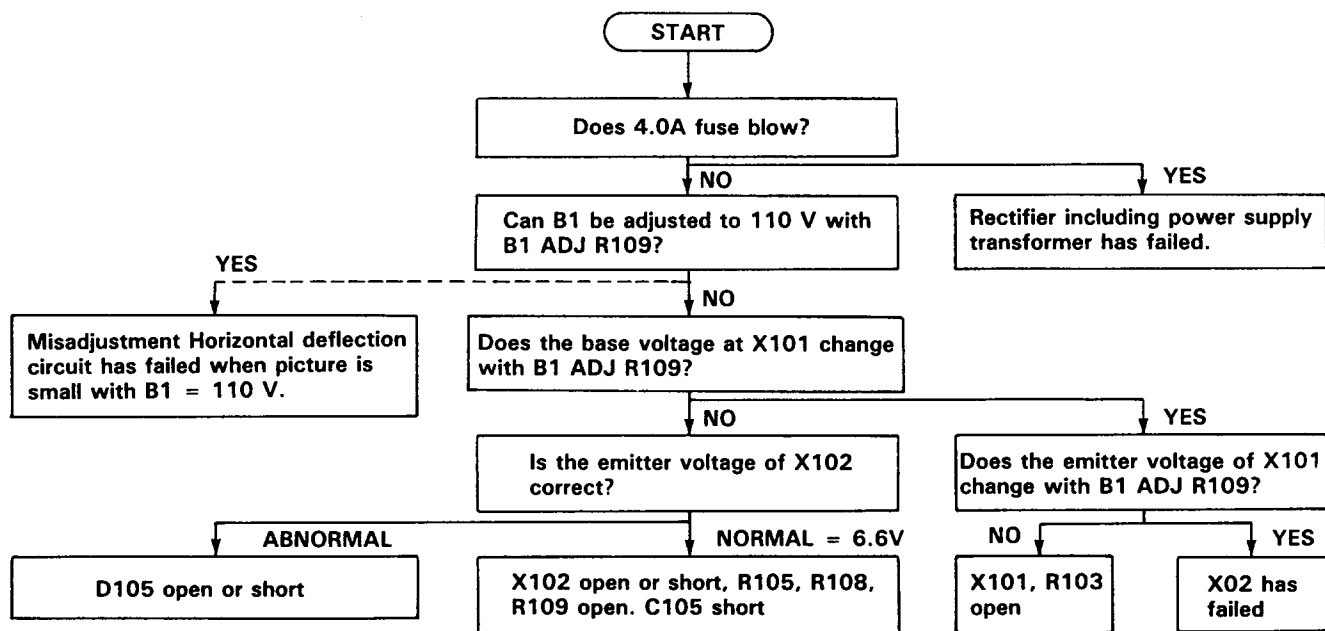
No raster, no sound (B₁ is abnormal)

Abnormal B₁ voltage indicates trouble in the power supply circuit. When B₁ voltage is not only low but also abnormally high, X701 (Q501) of the X-ray protector is turned on, setting the collector voltage to 0 V. The horizontal oscillator is then disabled resulting in no raster and no sound.

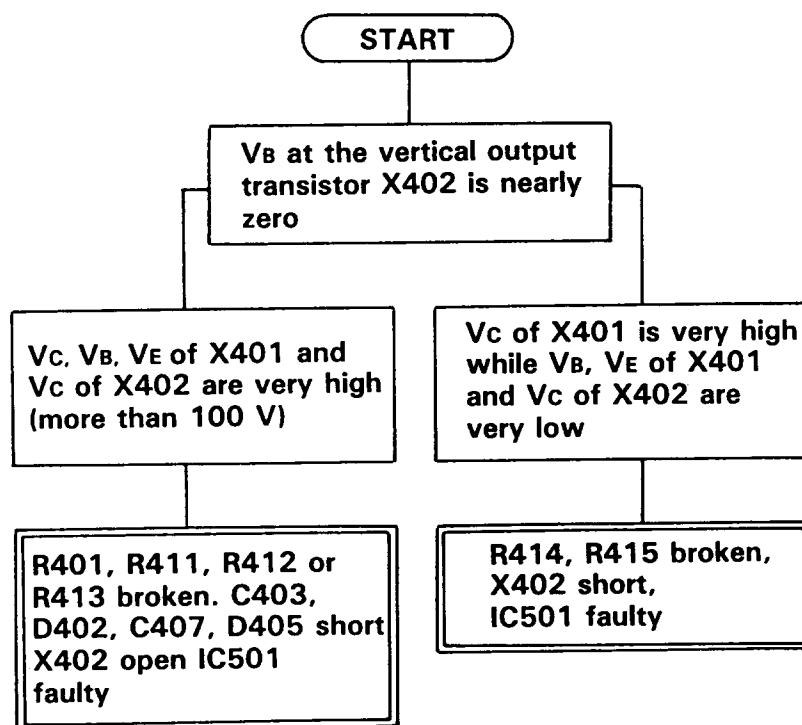
Only single horizontal line, normal sound

[Cause] Malfunction of the vertical deflection circuit. When the vertical deflection circuit is faulty, saw-tooth current is not applied to the vertical deflection coil, resulting in a single horizontal line. During troubleshooting, reduce brightness contrast to prevent an ion spot on the CRT.

1. R401 broken, C403, D402, C413 short: B2 12V is not supplied, disabling IC501.
2. R411, R412 broken, C407 short: the voltage at IC501 pin 3 is set to zero disabling the V-amplifier and the voltage at pin 2 is set to zero to turn off X402.
3. R414, R415 are broken: V_B of X401 is zero disabling X401 and X402.
4. Also check if C402 is short or open.
5. Too high V_B of X402 is because of C401 short or failure in IC501 or X402.

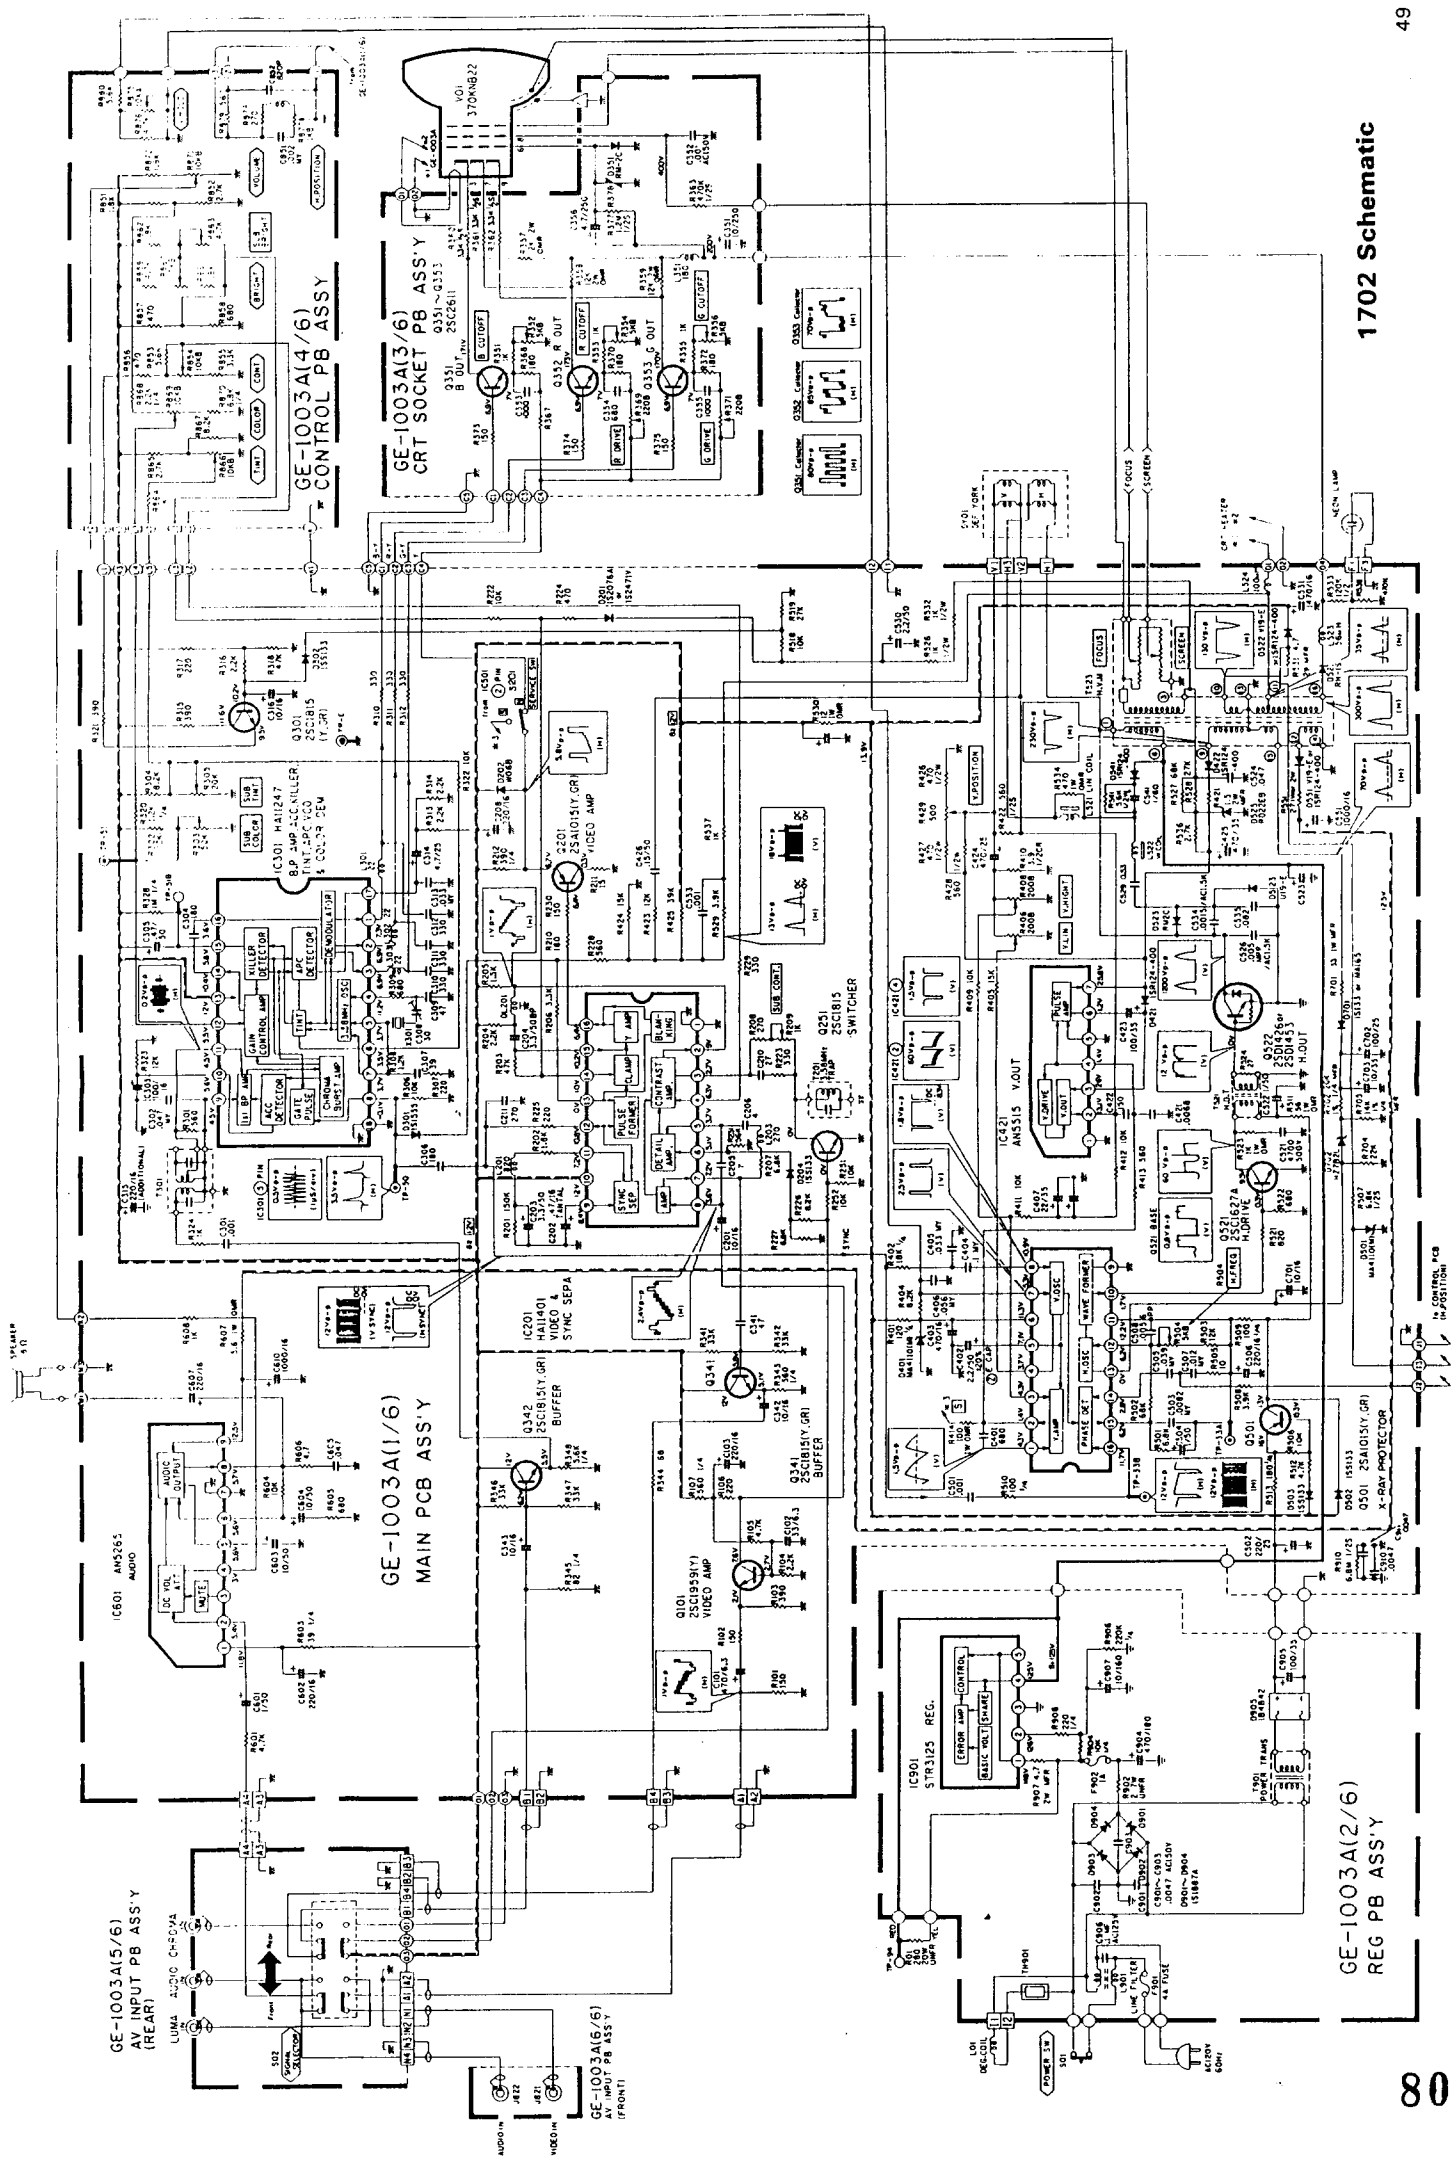
1702 Schematic

GE-1003A(5/6)
AV INPUT PB ASS'Y
(REAR)

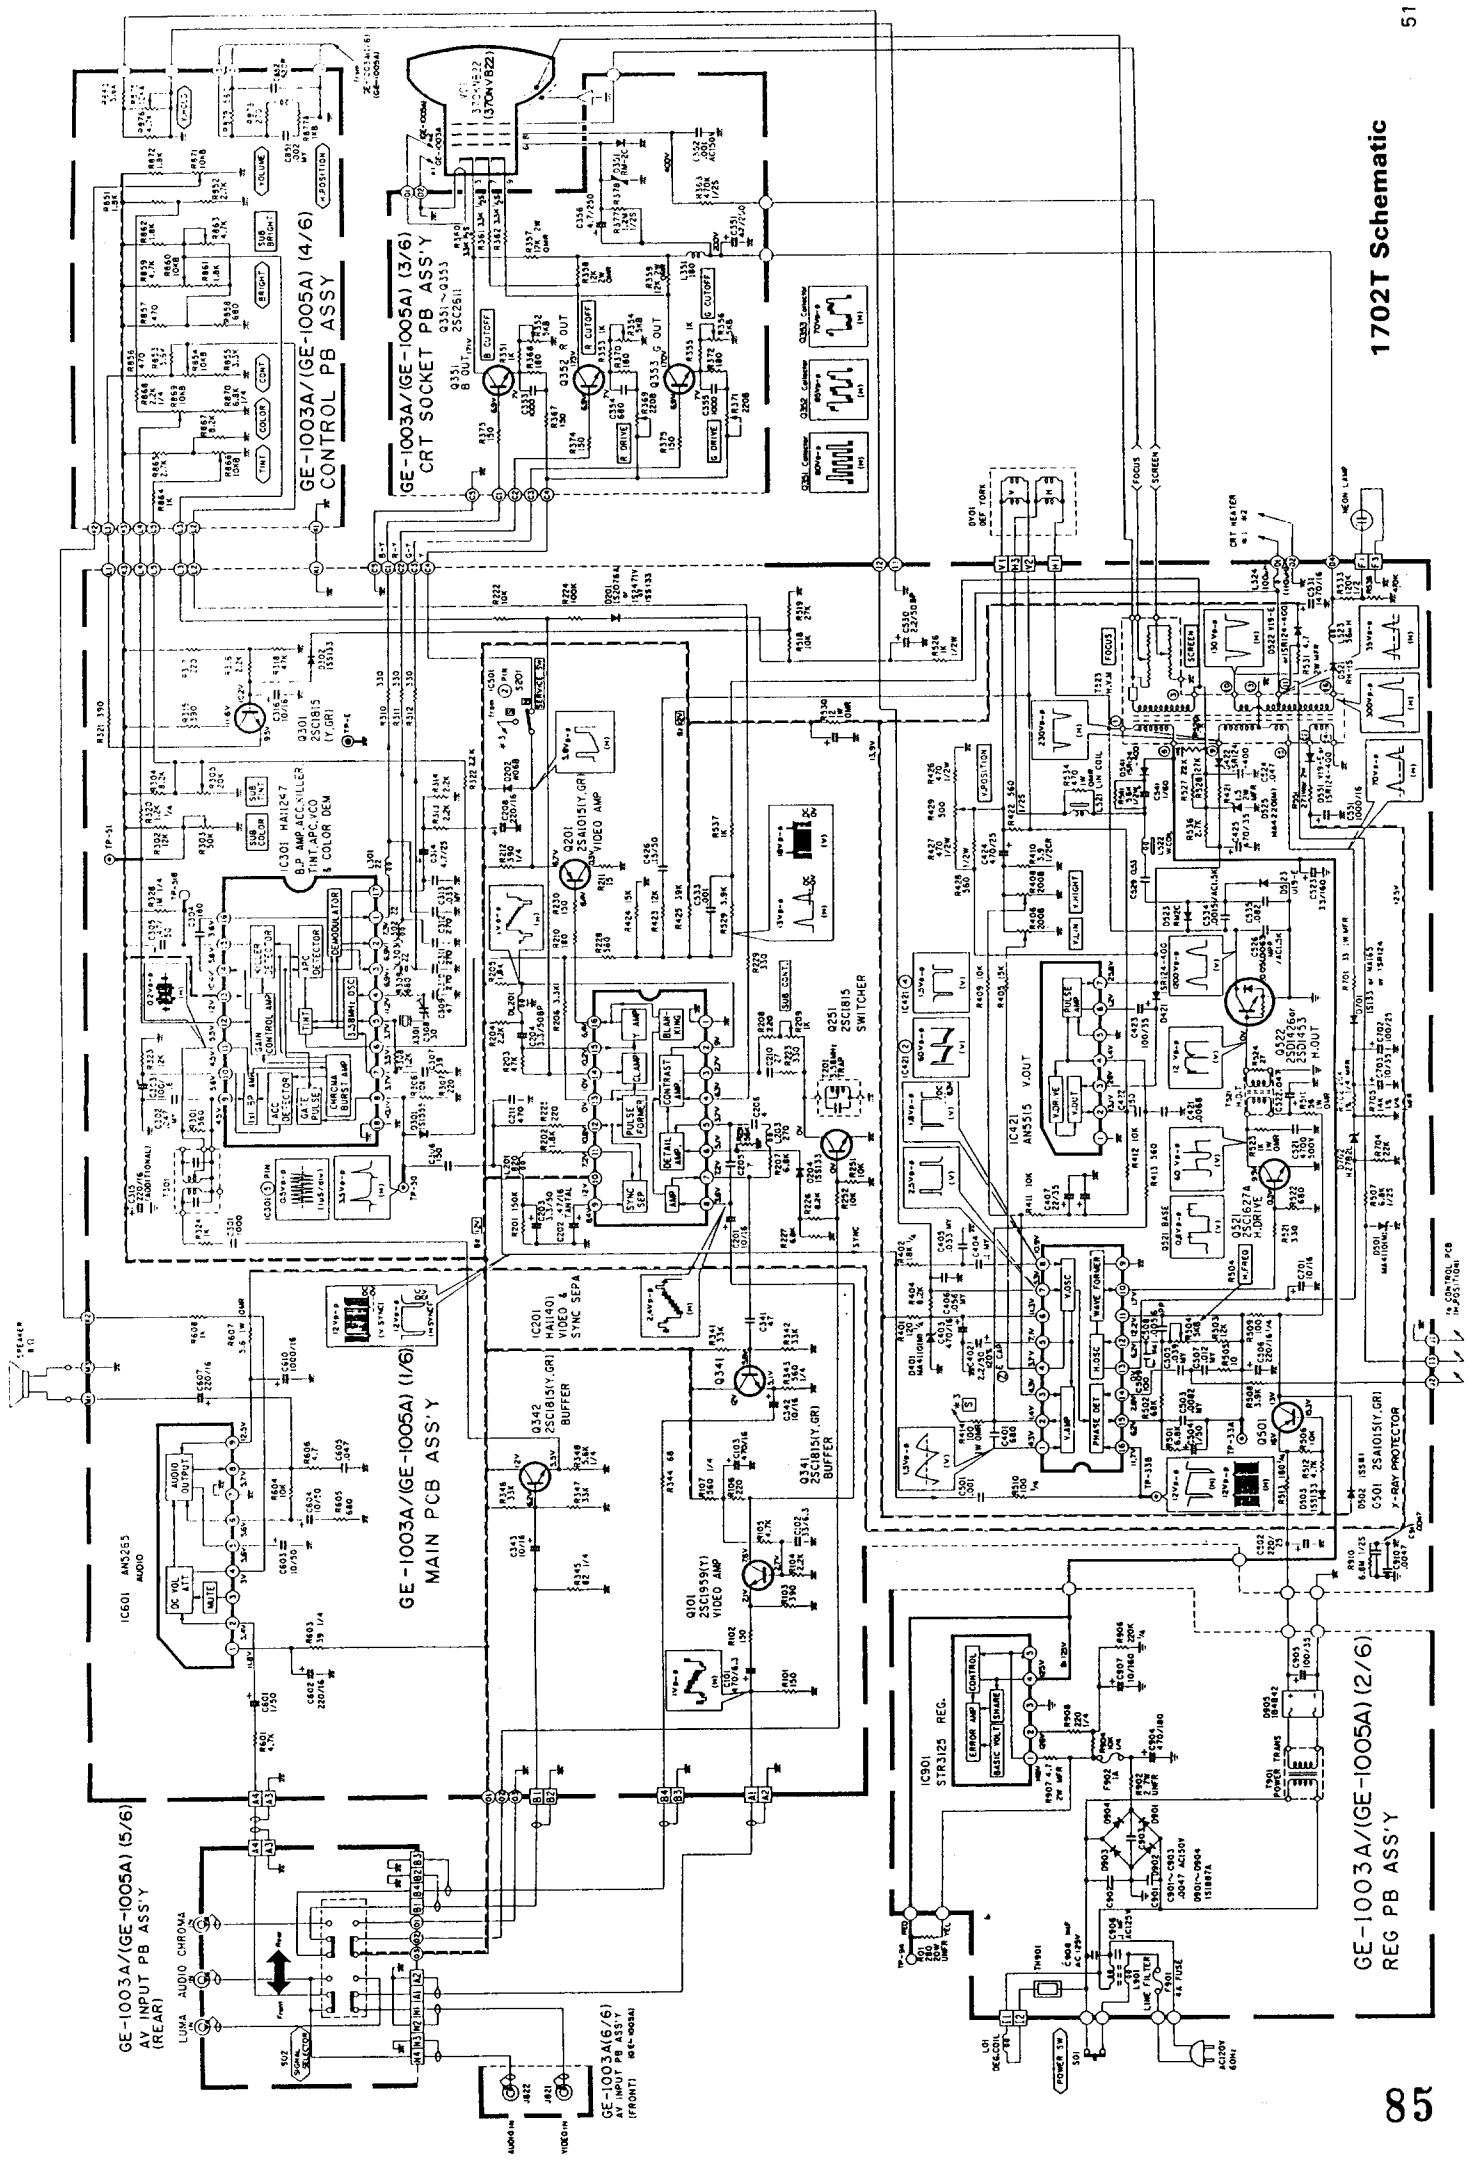
1702T Schematic

GE-1003A/(GE-1005A) (5/6)
AV INPUT PB ASS'Y
(REAR)
